How Onagawa Responded at the Time?

The Nuclear Power Station
That Withstood the Great East Japan Earthquake

A Report from the Scene by
Science Journalist
Wako Tojima

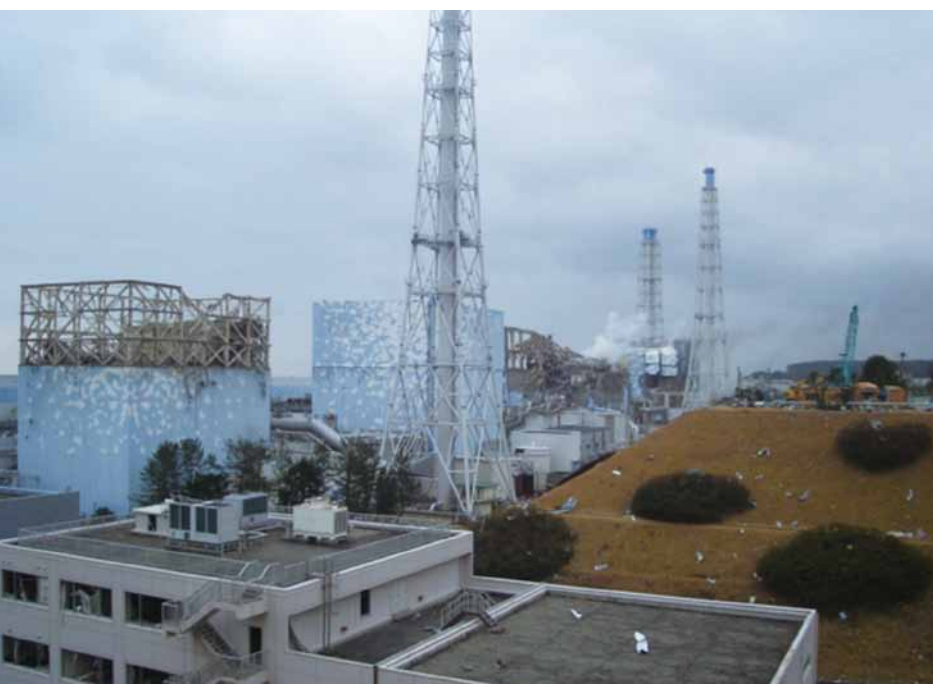
Fukushima Daiichi Nuclear Power Station following hydrogen-air explosions

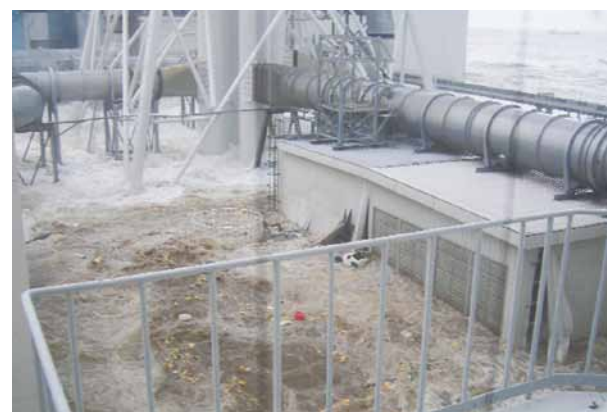
Fukushima Daiichi Nuclear Power Station when the tsunami arrived

Comparing tsunami wave heights, at Daiichi Units 1 to 4 they varied from 11.5 to 15.5 meters. At Units 5 and 6 the waves were 13 to 14.5 meters high. Whereas Units 1 to 4 are situated at a height of 10 meters, Units 5 and 6 are at 13 meters.

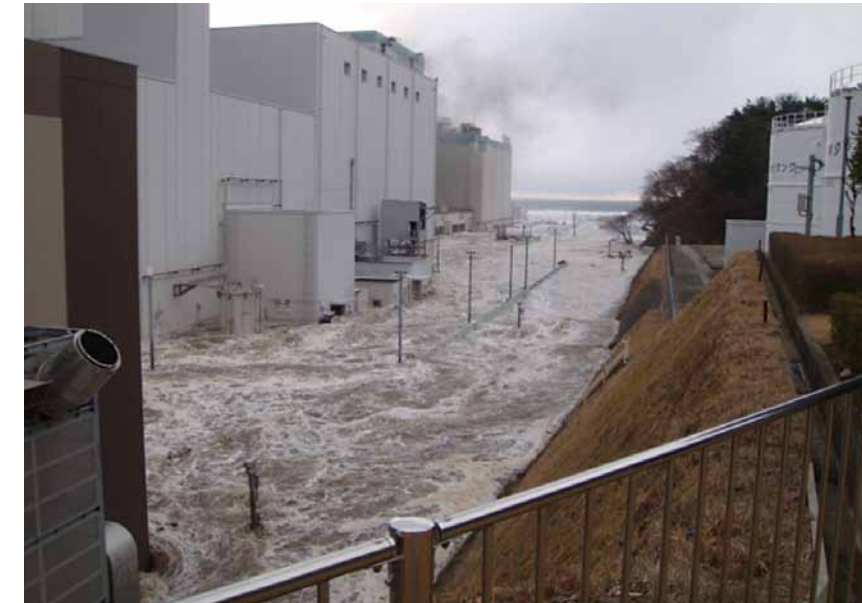
Fukushima Daini Nuclear Power Station when the tsunami arrived
Photos: Tokyo Electric Power Co.

Meanwhile, there was Fukushima Daini located 10 km from Daiichi. The inundation height here was around 7 meters and the site is located at a height of 12 meters. The effects of the tsunami were

accordingly less severe than at Daiichi. Even so, the tsunami came in with considerable force toward the mountain side, causing water to flow into the buildings.

As a result, the emergency power for Unit 1 was flooded. All the seawater pumps were also knocked out, with the exception of Unit 3.

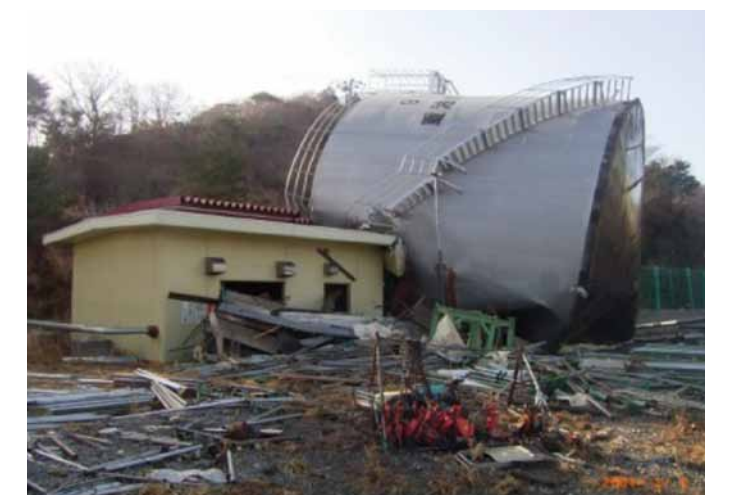
Toppled heavy oil storage tank (Stored amount when toppled: approx. 600kl)

The main damage from the tsunami was flooding of buildings adjacent to the Unit 2 reactor building and toppling of a heavy oil storage tank near the bay. None of this damage had any effect on cold shutdown of the reactors.

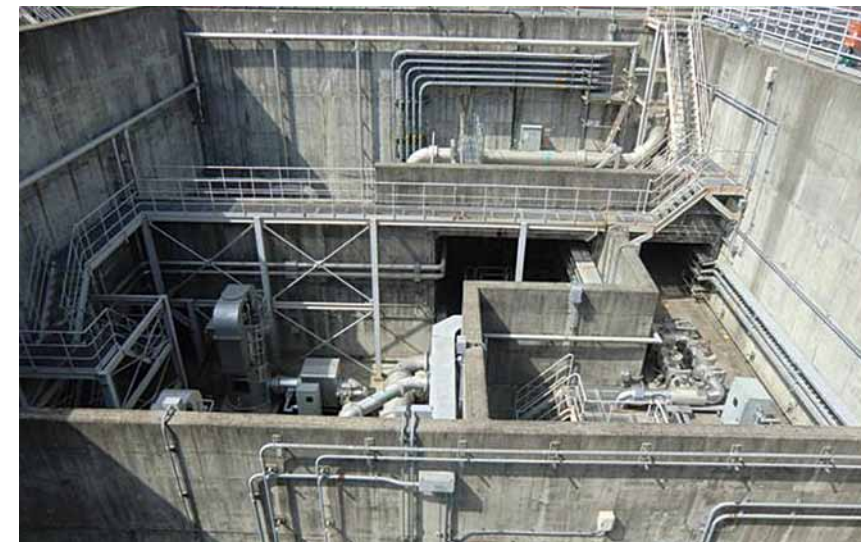
Seawater pump room pit

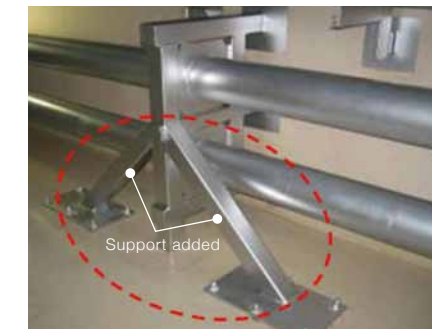
Pipe with support added

The towers supporting the exhaust ducts were also reinforced with steel, and the towers and ducts were connected by seismic dampers, in order to increase the seismic margin further.

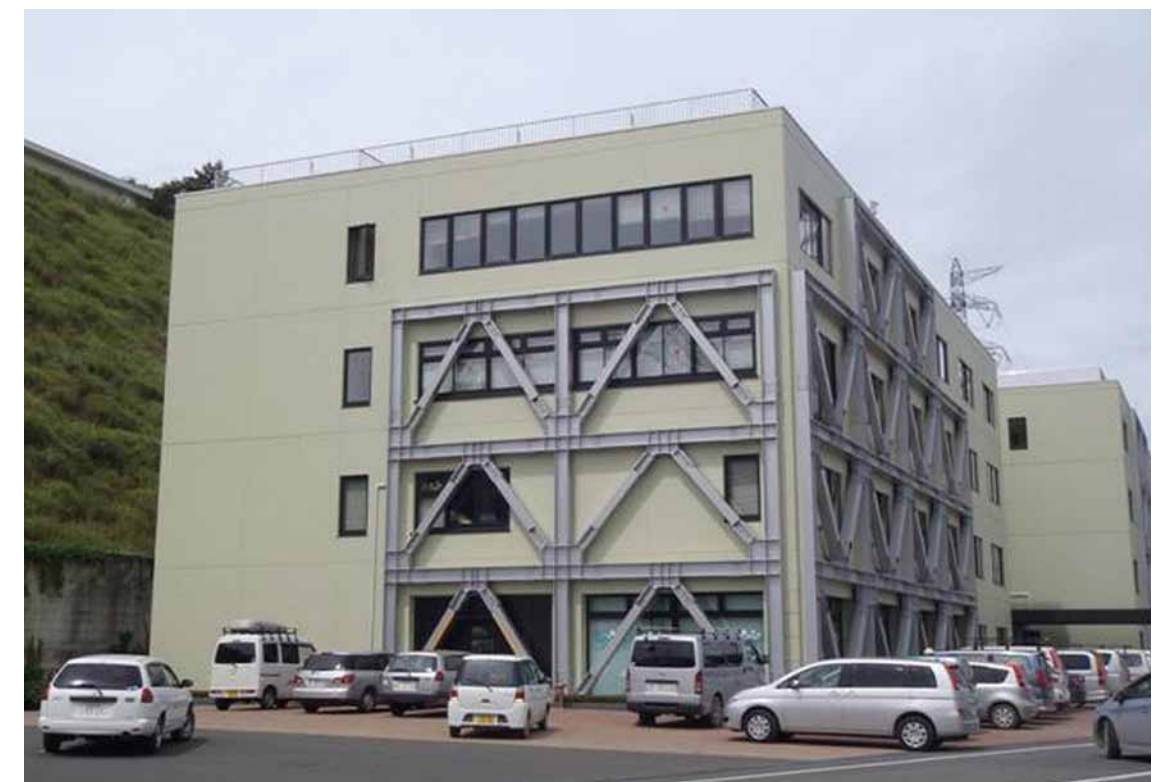
Fig. 8 Strengthening of flood wall (embankment protection)

Old administration building that had been reinforced with braces for improved seismic resistance

Based on what was learned from the Niigata Chuetsu-oki earthquake of 2007, major seismic reinforcement by means of braces had also been completed by 2010 in the administration building, including the emergency response room and computer room.

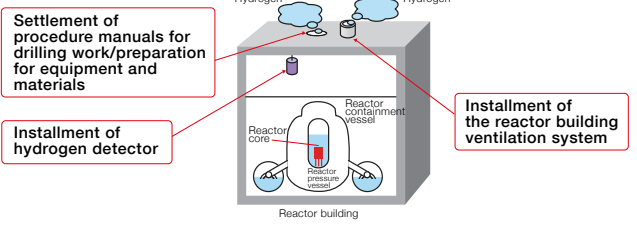
Installation of the reactor building ventilation and hydrogen detectors (BWR)

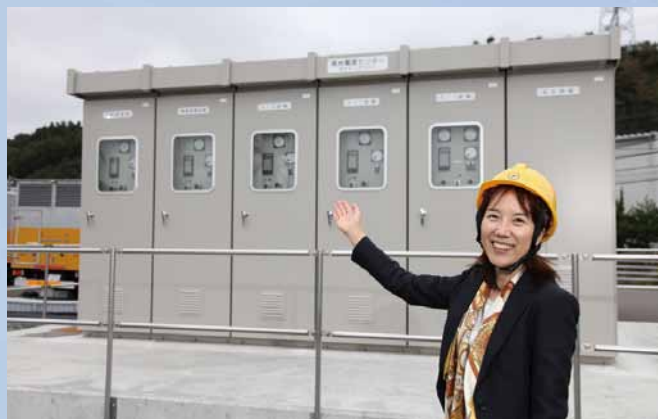
High-voltage power panel in elevated power supply center. Six power supply trucks, able to be connected by cable in an emergency, were also deployed at this elevated site.

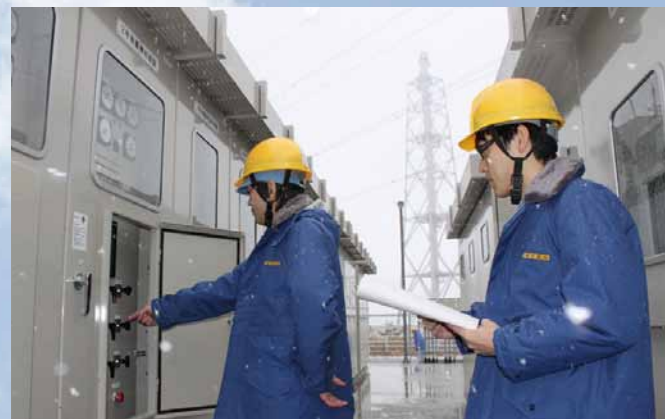
Practice starting large-capacity power supply equipment, conducted as snow falls

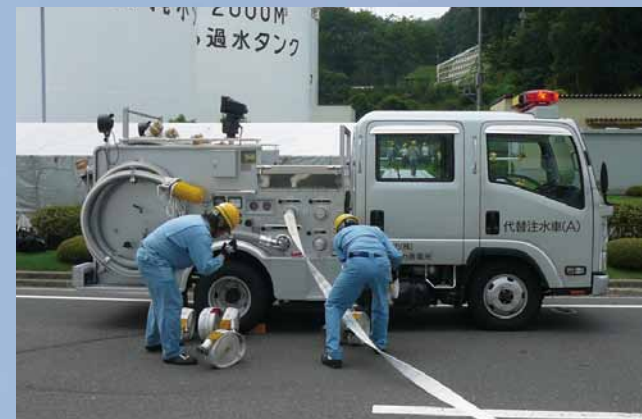
Practice securing water source with backup water truck (portable pump). The water source (condensate storage tank) for supplying water from a tank to a nuclear reactor or spent fuel pool is replenished with coolant.

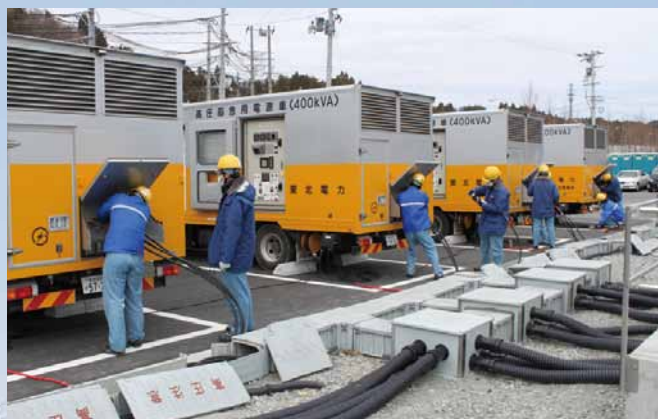
Practice hooking up power supply truck

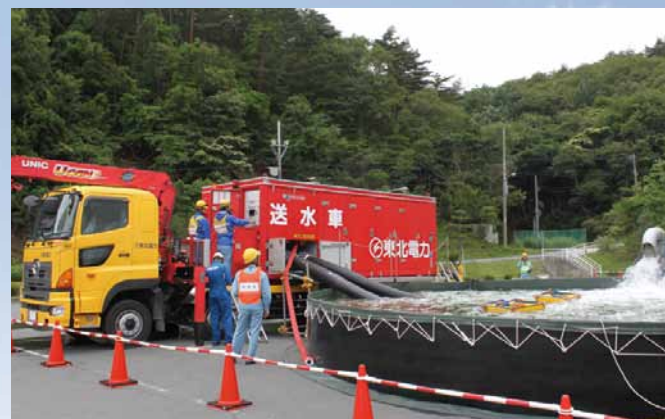
Practice sending water with water truck (backup seawater pump). If the regular seawater pumps cannot be used, the truck pump is used to pump up seawater from the ocean and send it on to the cooling system.

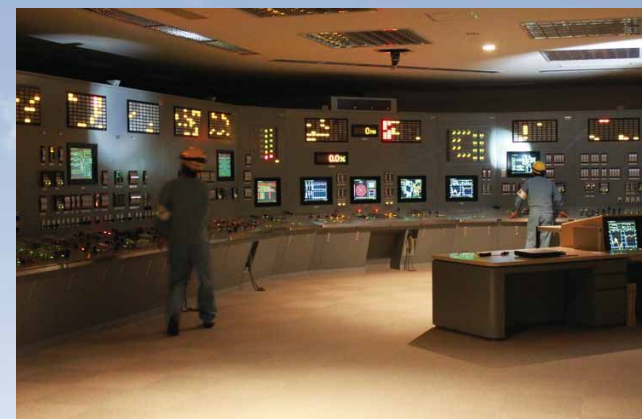
Operation training on simulator premised on loss of all AC power supplies
